# Manhole Inspection Summary

Manhole # S31GG2016MH

Insp Date: **11/29/06 2:27 PM**

**Location** Address: **5914 MEADOWOOD RD**

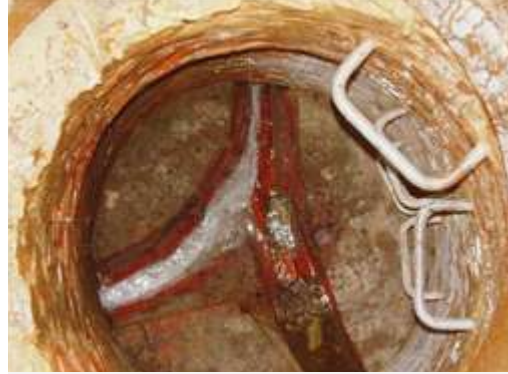
Top View

Evidence of surcharge - Bench debris.  
Channel debris.

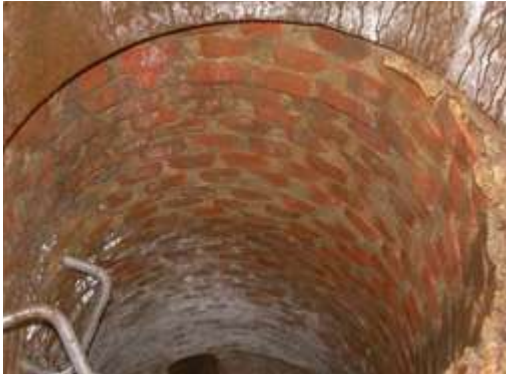
Defect

Adjustment deterioration and infiltration.  
Corbel and Barrel infiltration - other side.

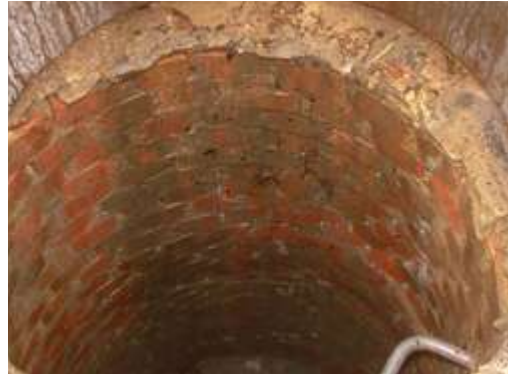
Defect

Frame offset. Adjustment deterioration  
and infiltration. Corbel and Barrel  
infiltration.

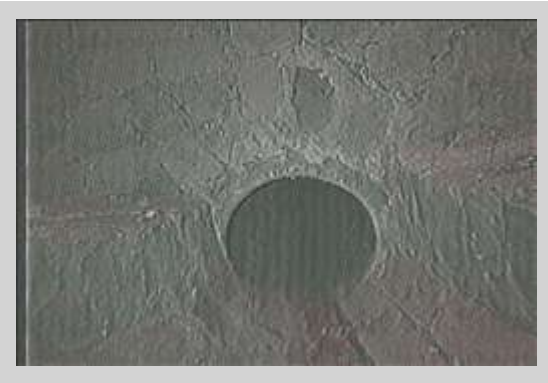
Pipe Out @ 12 O'Clock

Barrel deterioration and infiltration. Channel deterioration.

Infiltration: **Evidence** Pipe Seal Cond: **Cracked**

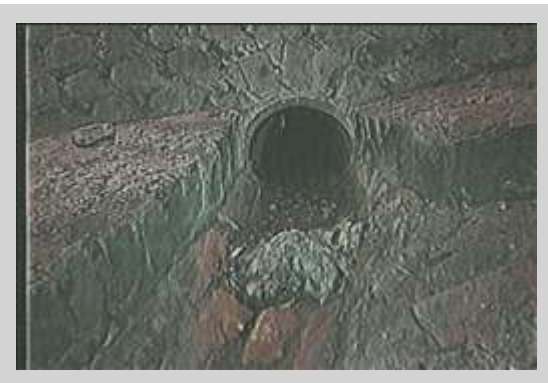
Pipe In @ 5 O'Clock

Barrel deterioration and infiltration. Channel deterioration. Channel debris.

Deposits: ☐ None ☒ **Mud** ☐ Sludge ☒ **Debris** ☐ Grease

Silt Depth: **0.5** (in.) Deposits Extent: **Light**

Infiltration: **Evidence** Pipe Seal Cond: **Cracked**
